PASSAIC RIVER BASIN,
TROY BROOK, MORRIS COUNTY
NEW JERSEY

LAKE INTERVALE DAM
NJ00769

PHASE 1, INSPECTION REPORT
NATIONAL DAM SAFETY PROGRAM

MAY 1981

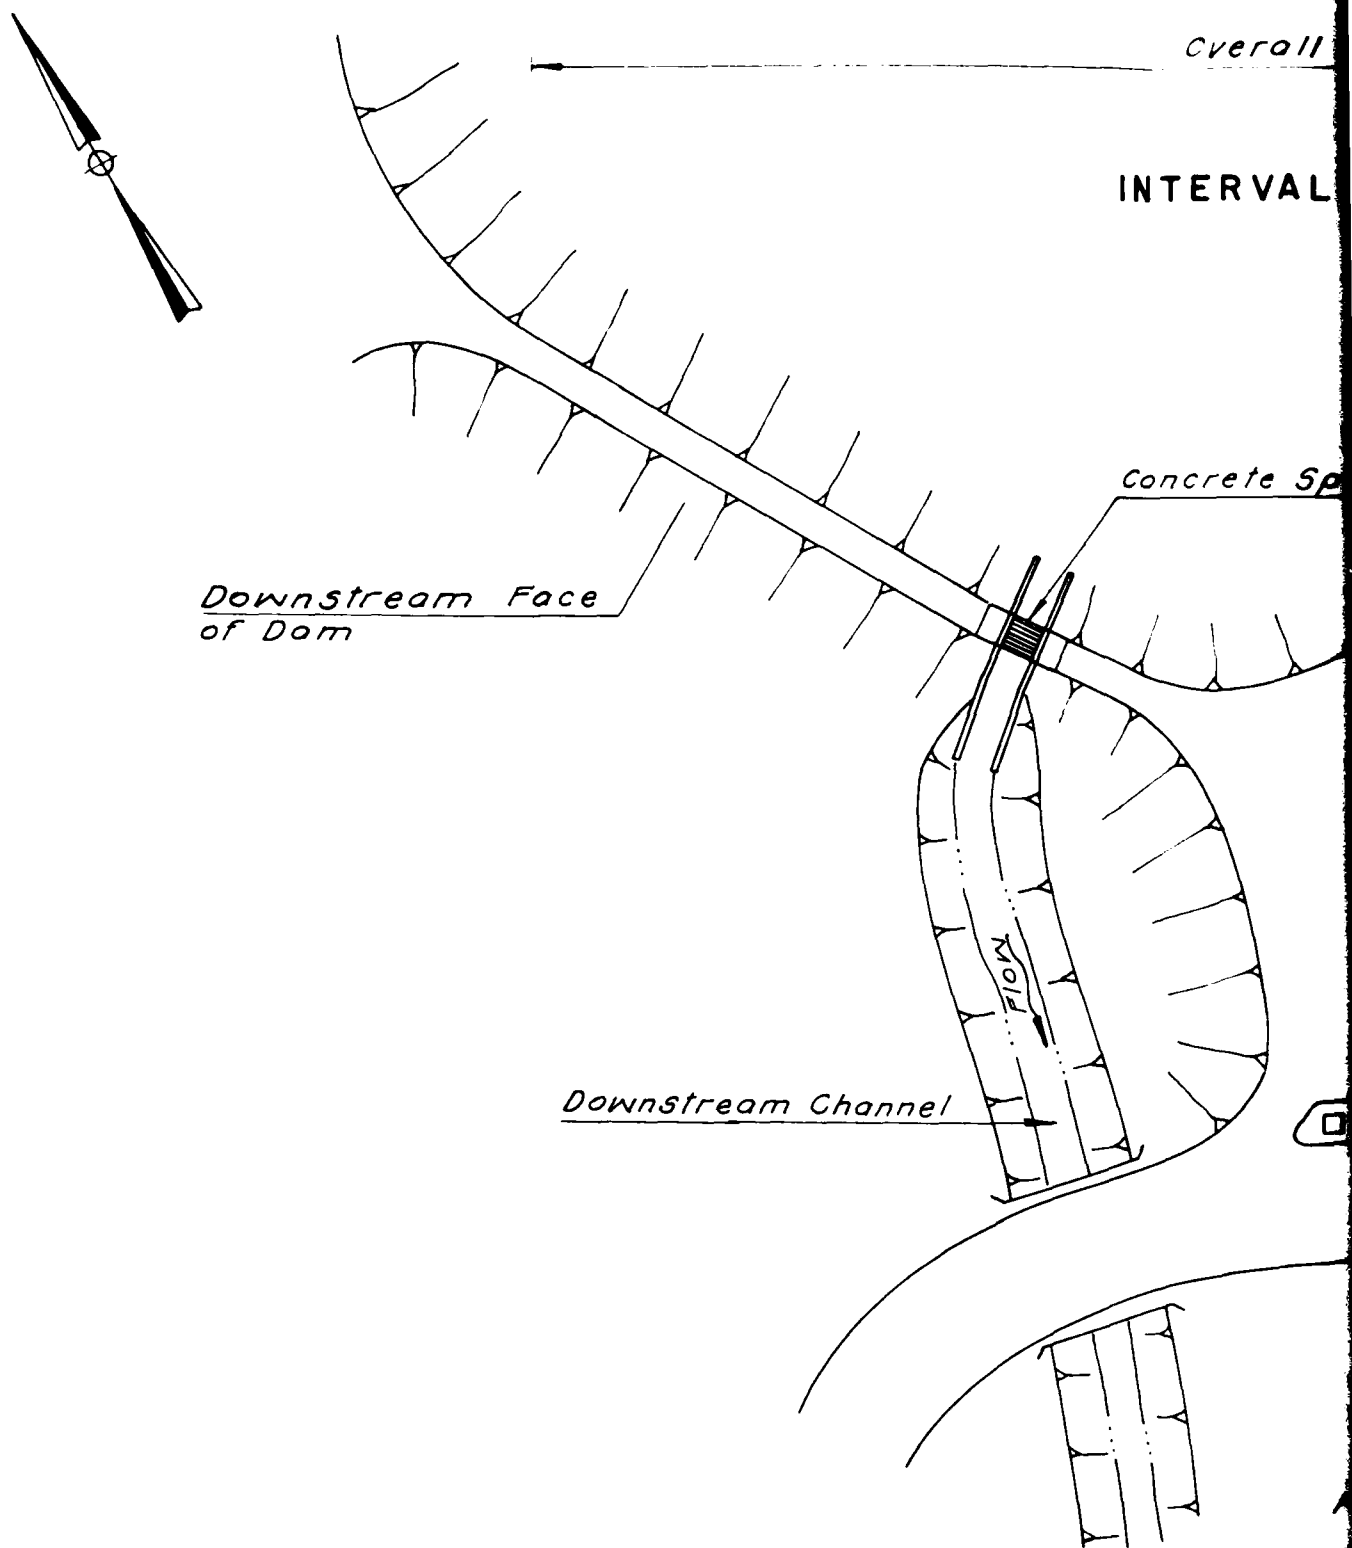
- 1. Information taken from field inspection December 18, 1980*
- 2. Dredging operations in progress at time of inspection.*

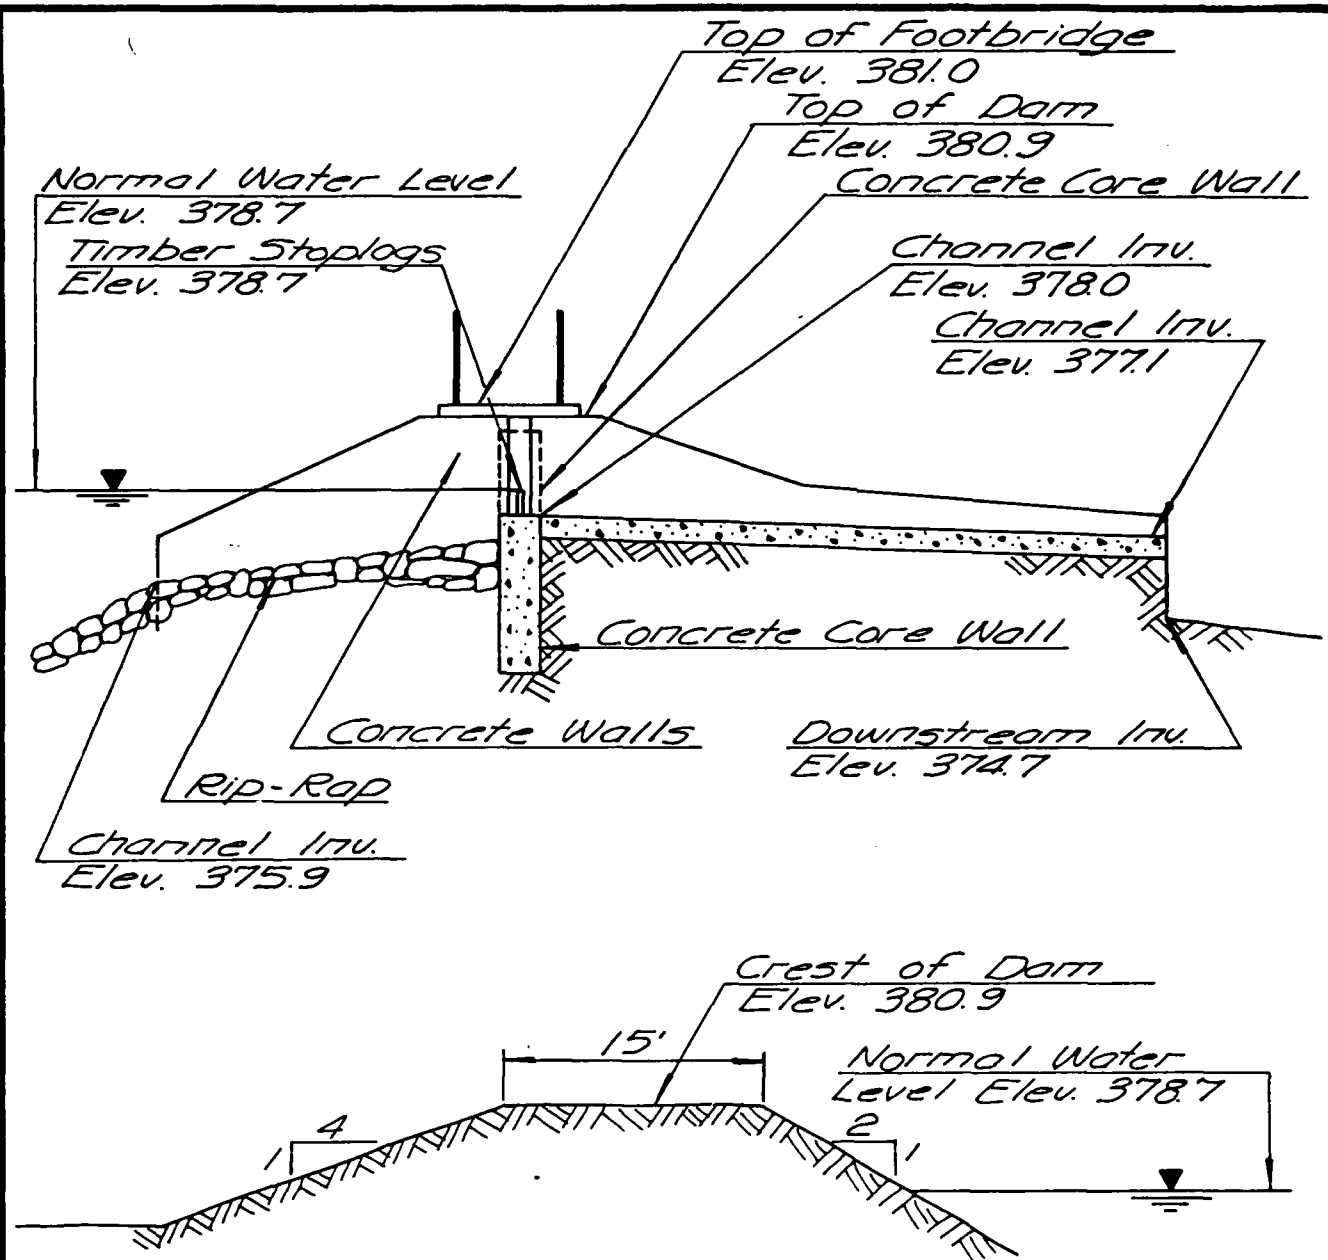
1. Information taken from field inspection December 18, 1980.
2. Lake was drawn down at time of inspection.

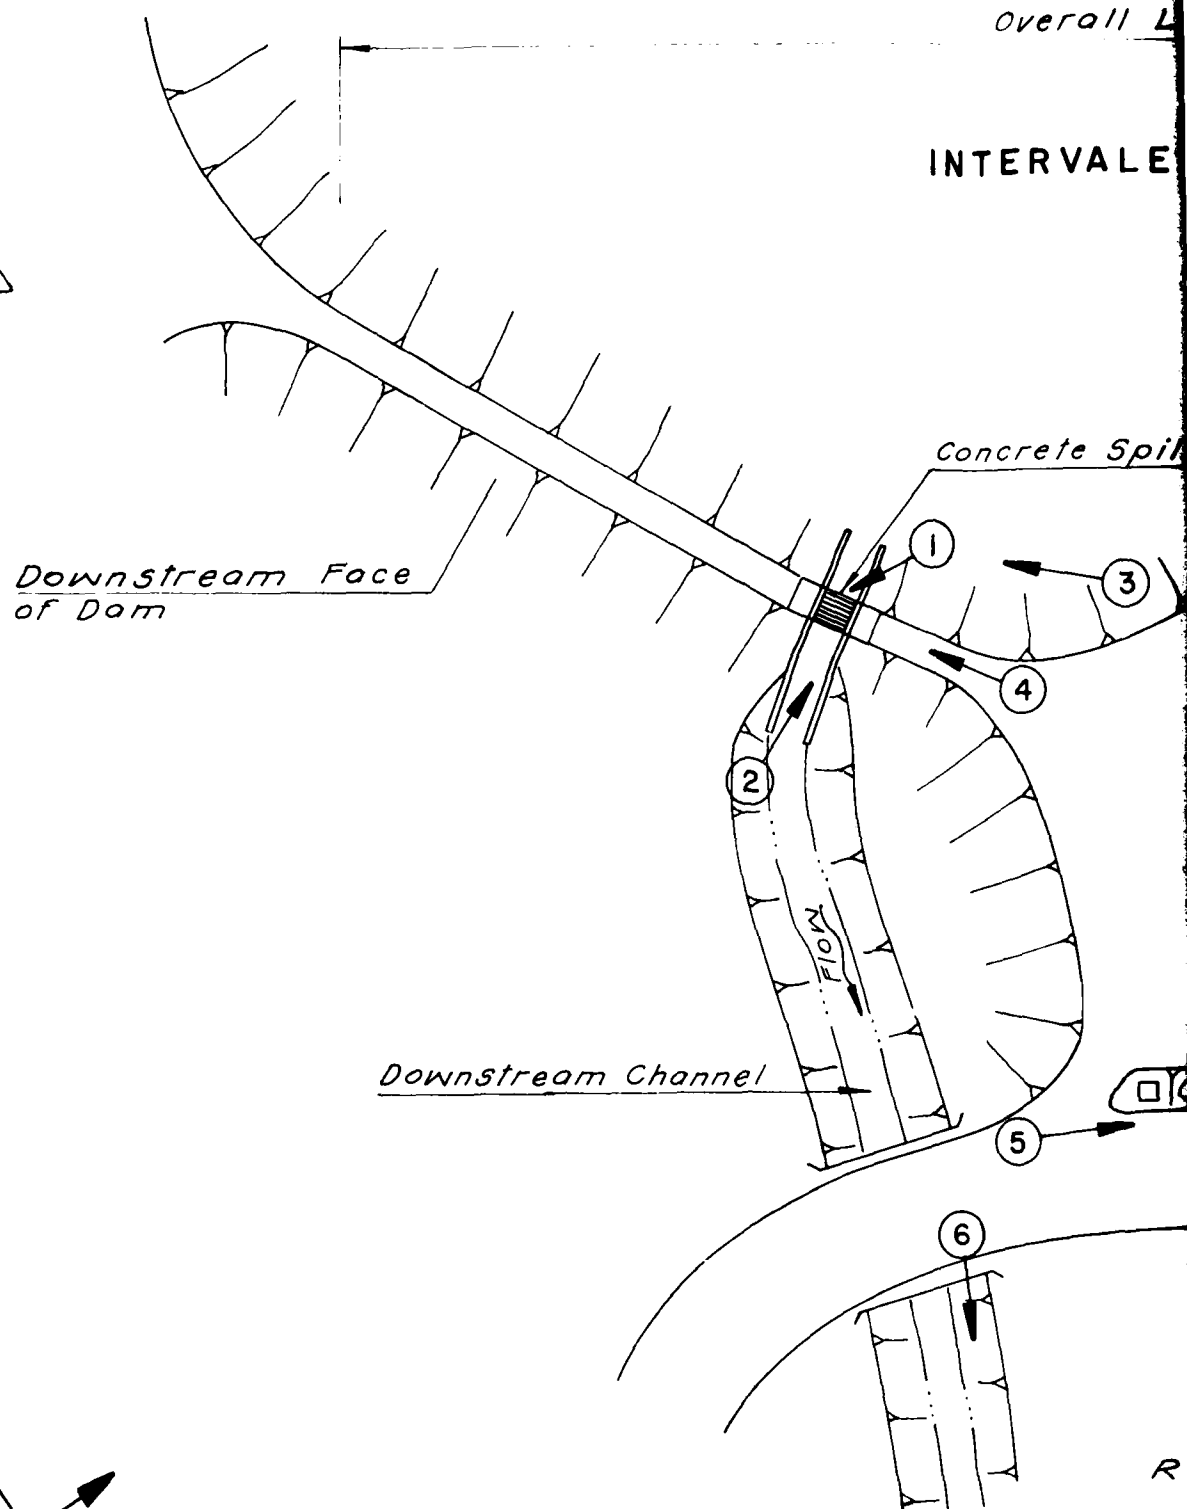
- 1. Information taken from field inspection December 18, 1980*
- 2. Dredging operations in progress at time of inspection.*
